Hurricane Pauline - its impact on Acapulco and subsequent debris flow prevention measures

Raymund M. Spang

Dr. Spang Civil Engineering and Geotechnical Consultants Ltd., Witten, Germany

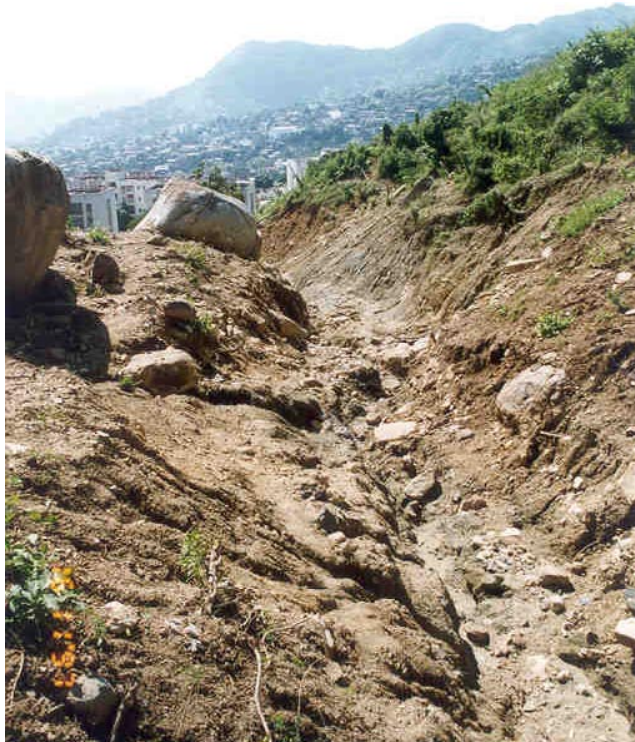
Figure 2. Gully below the crest of the Sierra Madre del Sur after Pauline; banks and bed have been deeply eroded; sandy silts with a high amount of pebbles are exposed.

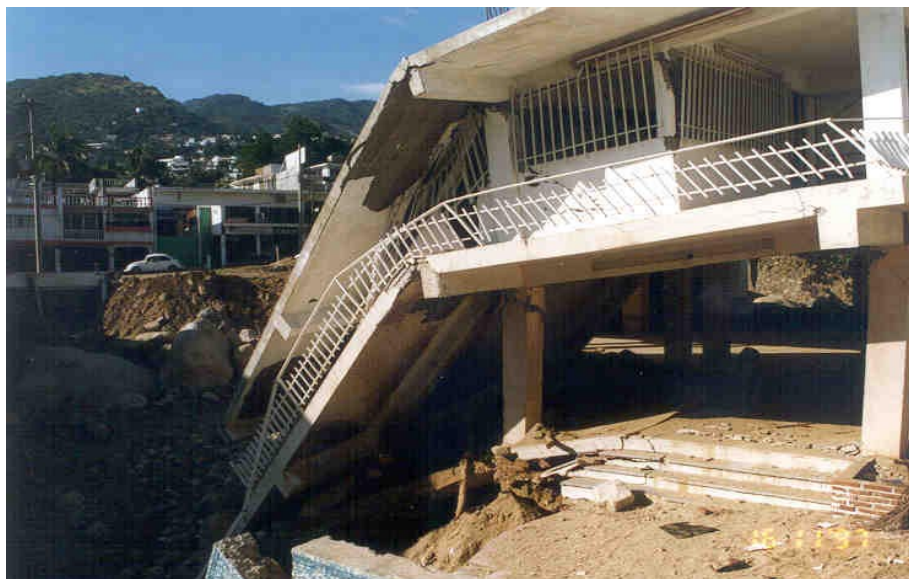
Buildings were destroyed either because of undercut foundations (Fig. 5) or by impact of debris flows. Mostly landslides and mudflows destroyed the huts within the rural belt.

Figure 5. Building devastated and partly collapsed after foundation undercut by torrent.

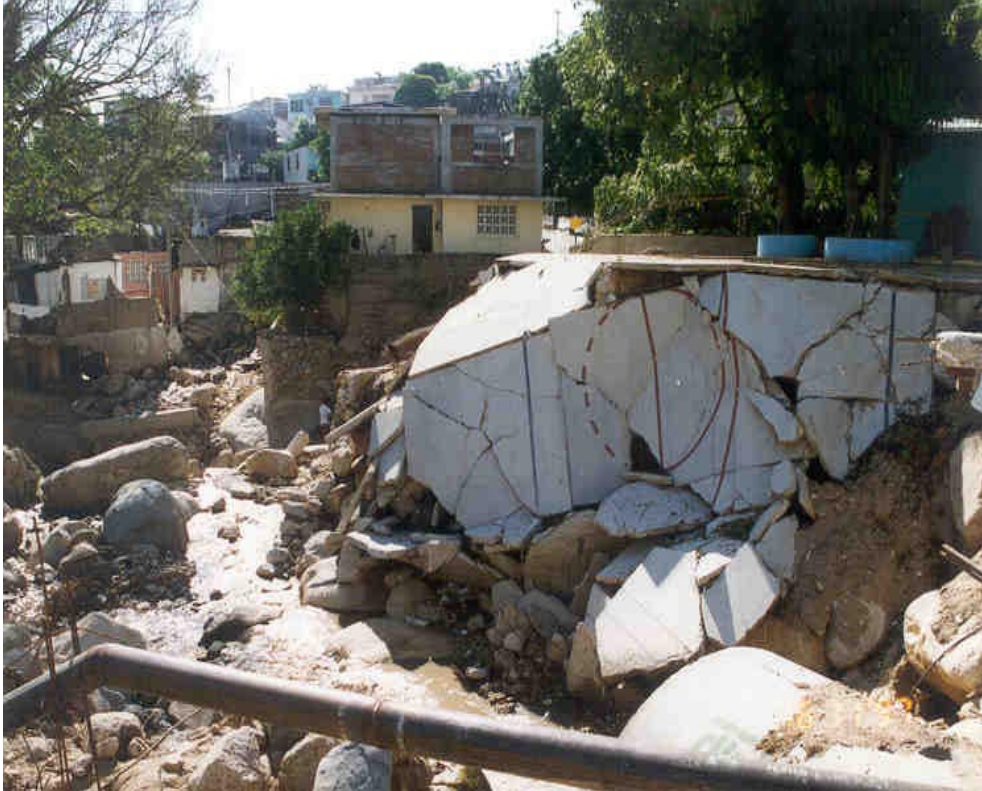
Many torrents left their blocked and narrow beds and changed their course completely, using neighboring depressions or adjacent streets as new beds (Fig.6). These streets were eroded up to 6 m below their original level. Along their course, houses were undercut leading to the collapse of the structures (Fig. 5).

Figure 6. The former street in the center is completely washed away, the basketball field to the right was undercut and collapsed.

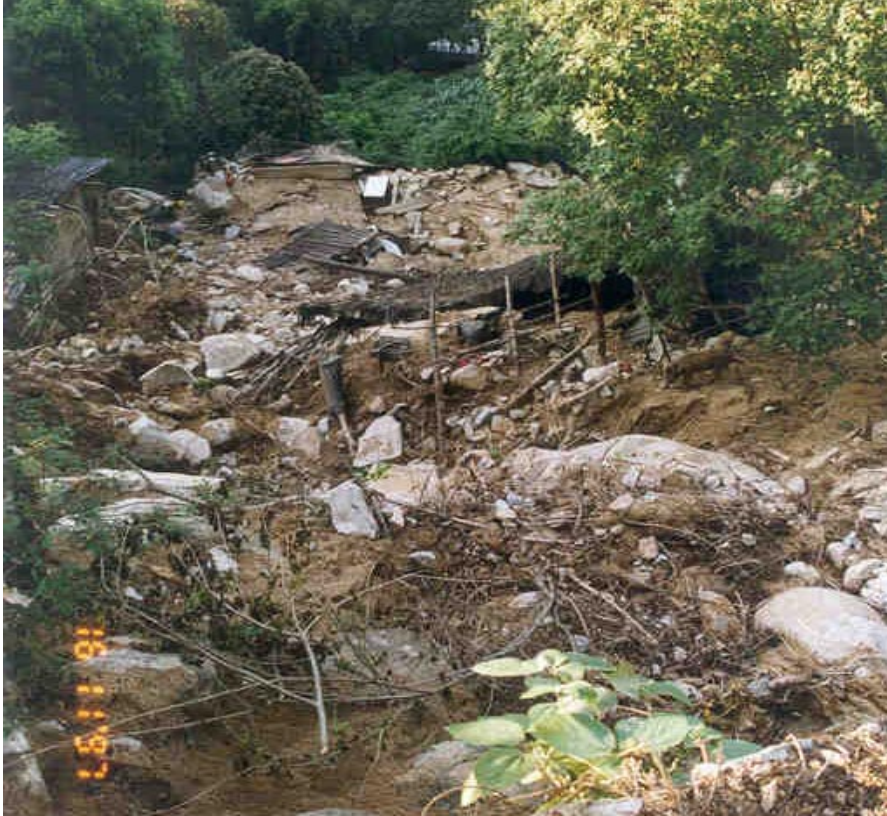
Figure 7. Huts destroyed by a mud flow.

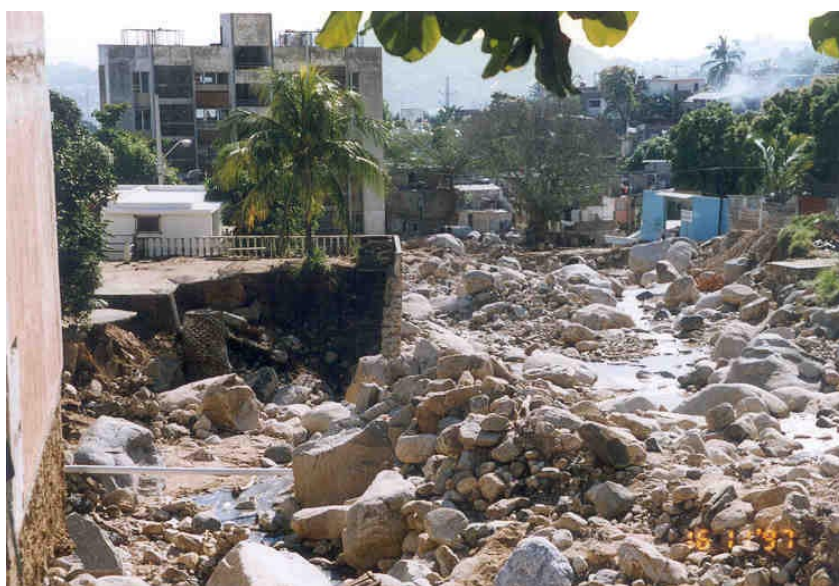
Figure 8. Devastations by a broken out torrent; destroyed culvert on the left, former street on the right side; side retaining wall of the inlet collapsed, street deeply eroded and destroyed.

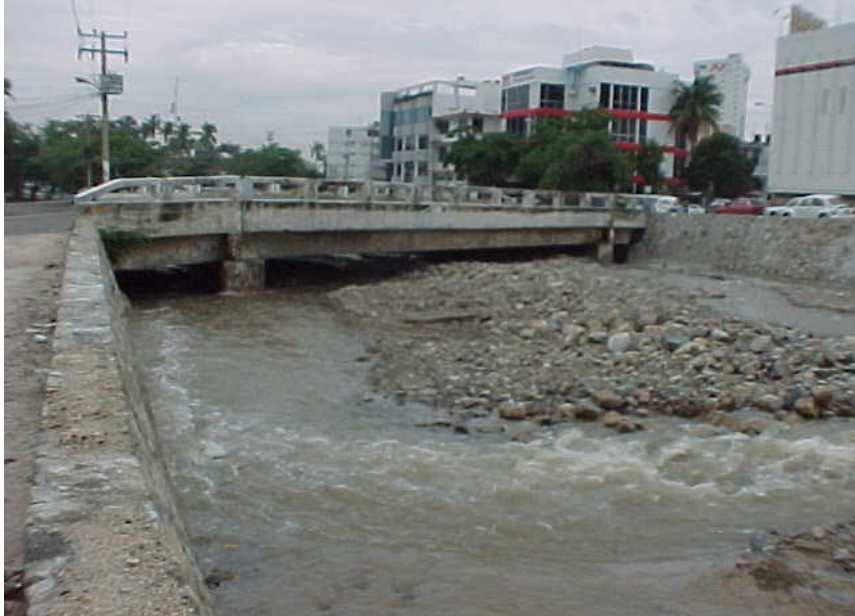
Figure 10. Andrés de Urdaneta Bridge over Arroyo Palma Sola Camarón, before rehabilitation.

All mitigation measures had to be executed to fit the small budget. First the huge amount of debris having blocked the lower part of the 8 major creeks (Fig. 10) was removed; the riverbeds were straightened and enlarged. Bottom and walls of the drainage channels were systematically protected by masonry, especially the Palma Sola, Aguas Blancas, and Costa Azul creeks (Fig. 11).

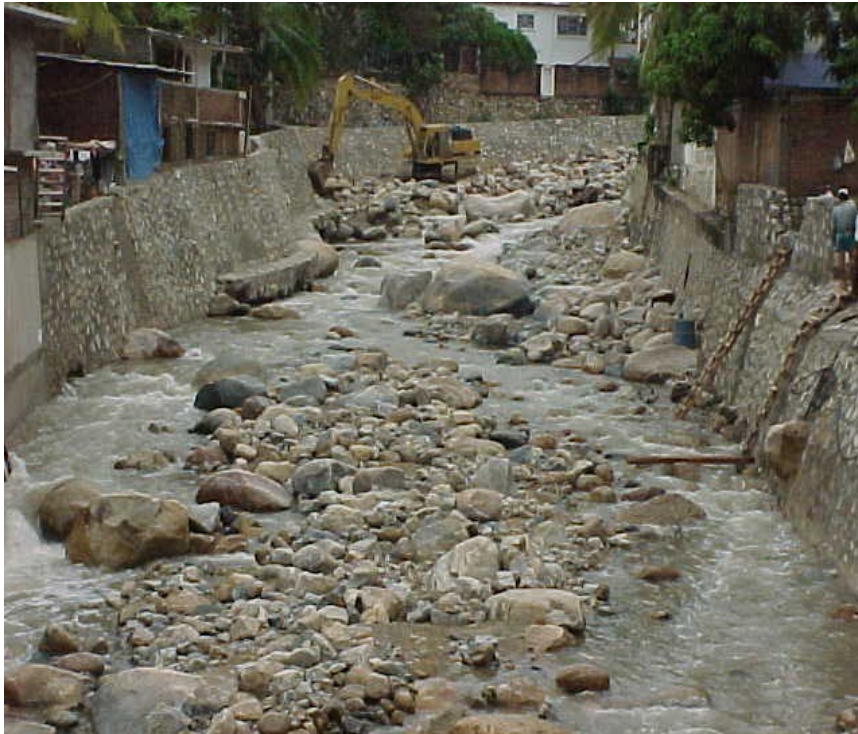
Figure 11. Drainage channel Arroyo Palma Sola Camarón during repair of walls.
