Hurricane Pauline - its impact on Acapulco and subsequent debris flow prevention measures

Raymund M. Spang

Dr. Spang Civil Engineering and Geotechnical Consultants Ltd., Witten, Germany

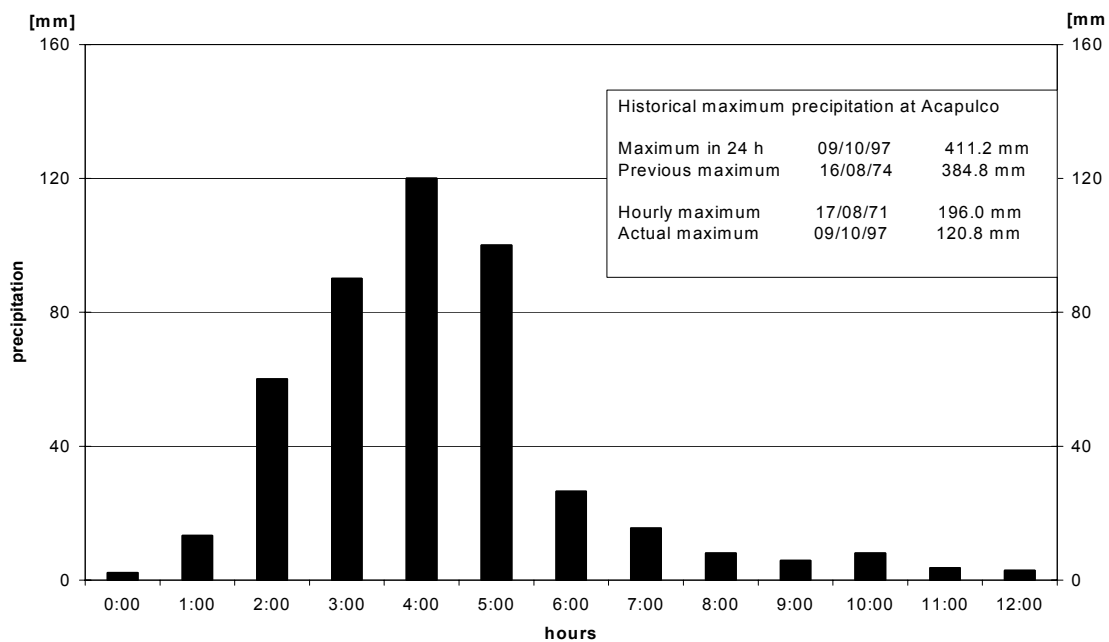
During the well-recorded 46 years between 1941 and 1987, Acapulco was hit quite regularly by hurricanes from August to mid of September. The longest duration was 11 days. Normally the hurricanes lasted between 1 and 6 days. The usual number of events per month was 5 to 7. The historical maxima are summarized in Figure 3 and compared to Pauline. It can be recognized that Pauline slightly exceeded the previous 24 hours maximum, but did miss the hourly maximum considerably.

Figure 3. Comparison of precipitation between previous hurricanes and Pauline as for their total and 24 hours maximum; development of precipitation by Pauline on Oct. 09, 1997 after Centro Nacional de Prevención de Desastres, 1997.

On Oct. 9, 1997, at 2 a.m., Pauline reached the City of Acapulco. Accompanied by strong winds, it brought an excessive precipitation of 411 mm within 24 hours. Thus, Pauline exceeded its predecessor Gilbert's 350 mm within 24 hours. Most of the precipitation occurred within 4 hours, only (Fig. 3). The maximum hourly rate was 120,8 mm (2 mm/min.). The maximum value ever recorded before had been 196 mm/h (3.3 mm/min.).

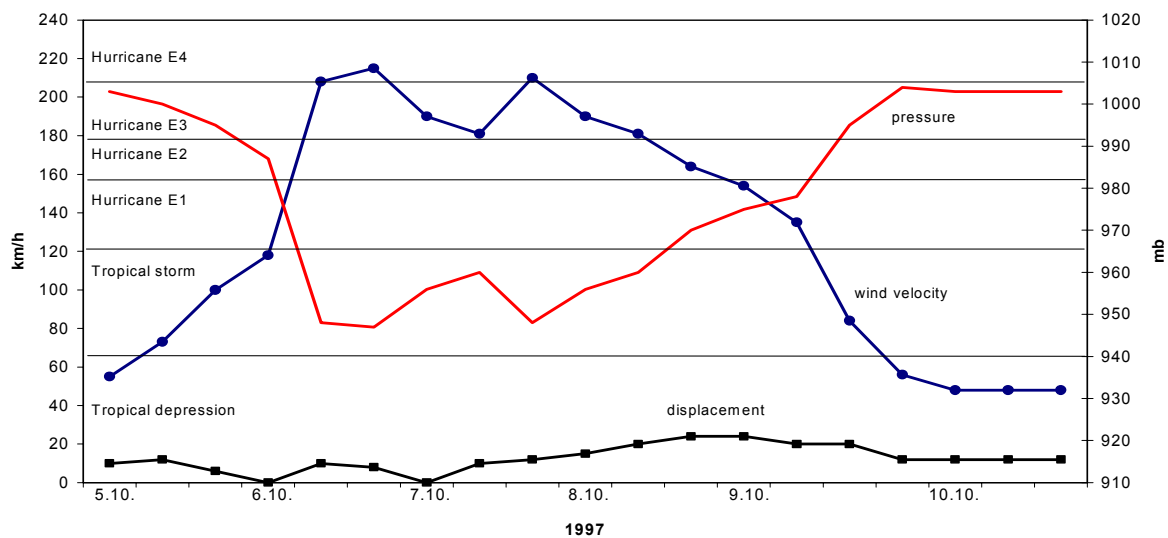
Figure 4. Classification of hurricane Pauline by development of atmospheric pressure, wind speed and migration velocity of its center.

Figure 4 describes the main characteristics of Pauline as atmospheric pressure, wind speed and migration velocity of its center as well as their development with time. According to this Figure, Pauline started on Oct. 5 as a tropical depression. On Oct. 6, at 4 a.m., it became a tropical storm. Only 12 hours later, it had reached the intensity of a hurricane. According to the scale of SAF-FIR/SIMPSON, it reached level E 4, representing highly destructive hurricanes. Wind speed reached 215 km/h with gusts up to 240 km/h. It kept this level for 3 days until Oct. 9, 5 p.m. It was not earlier than Oct. 10, when it fell below the lower limit of tropical storms. This very fast and unexpected development was one of the reasons behind the high losses caused by Pauline.

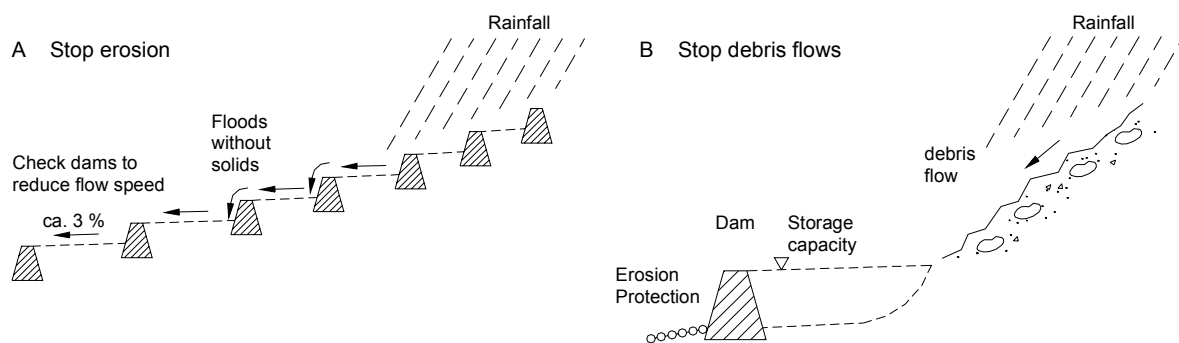
Because of the dense populated area and the high values to be protected, only active measures came under consideration. There were two basic approaches to protect the inhabited areas as shown on Figure 9.

Figure 9. Cross sections showing the two basic approaches of stopping erosion and controlling debris flows in principle.

Solution A: Erosion control by reduction of run-off and stabilization of slope surfaces by reforestation and protection of torrent beds and banks by construction of check dams and rough reinforced beds to slow down flow speed below the critical value of the tractive force according to López Cadenas de Llano (1993), Deymier et al. (1995) and Matsushita (1998).

For Aguas Blancas and its 13.6 km of gullies and creeks 600 small check dams with a total volume of 40.000 m³ would have been necessary, assuming a gradient between the dams of 3% and an average dam height of 3 m. In addition 2.000 m³ of gabions for bank protection, 40.000 m² of reinforced torrent and creek beds as well as 20.000 m² of landslide stabilization would have been required.

Solution B: Control of debris flows by debris retaining or debris flow control structures at suitable locations on the debris fan or on the deposition zone according to VanDine (1996), respectively; the decisive point is the drastic reduction of the gradient to break the head of the flow and enforce the sedimentation of the coarse material. As an alternative for small channels modern barriers of ring nets could be used (Thommen 1998).
